Standard Safety

April 2009

Special Feature - Stowaways

An analysis of the problem

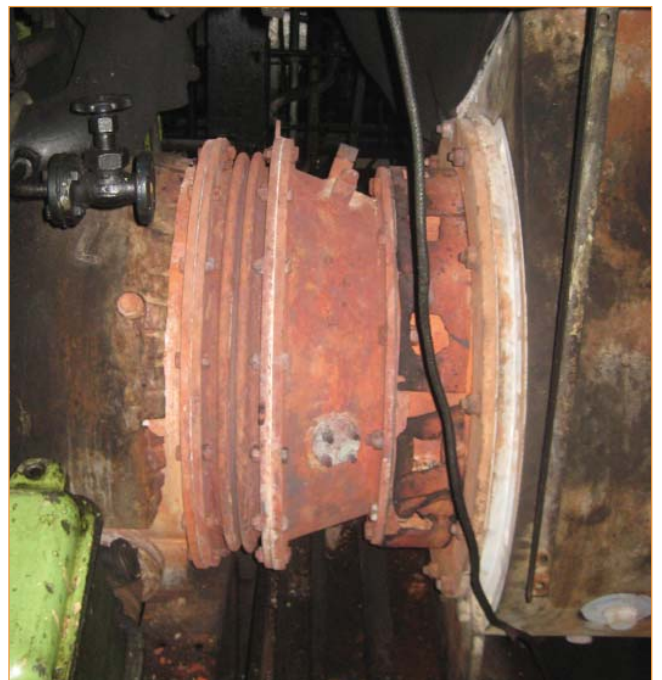
During a number of recent condition survey inspections carried out by the club's loss prevention surveyors, a number of main engine and generator exhausts have been identified as not being adequately insulated and covered. Some of these deficiencies were even found on passenger ferries. Not always considered a P&I matter and more often thought of coming under 'Hull and Machinery', the effects of an engine room fire have a direct impact on the safety of the crew and passengers, and can result in the ship grounding (wreck removal), and / or a general average situation where the club could be liable for the cargo interests proportion of general average.

It is universally accepted that the majority of fires in engine rooms are caused by a lubricating or fuel oil pipe failing and spraying oil onto a hot exhaust. This could be because of a failed pipe connection or olive, a pipe fracture caused by fretting due to vibration or over tightening. The hot exhaust is available as the source of ignition because the insulation is either not adequate, already oil soaked or has not been fitted correctly. Often, as can be seen from the picture below, the insulation is not there at all. For example, the turbo charger has just been overhauled or the generator has been opened up for survey and the insulation has not yet been replaced. Fuel or 'lub' oil pipe failure can occur at any time resulting in a major engine room fire.

Generator exhaust – without any insulation; a major safety defect

SOLAS states that 'all surfaces above 220 deg Celsius which may be impinged as a result of a fuel system failure shall be properly insulated'. Consider also the exhaust insulation near lubricating oil pipes. A fractured lubricating oil pipe can as easily cause a fire as a fuel oil pipe fracture.

1. Masters should perform a weekly or fortnightly inspection that should include an inspection of the engine room. The master should not leave the inspection of the engine room to the chief engineer alone. The master can see if there are any major defective housekeeping issues, fuel/water/lub oil leaks, defective safety barriers and poor protective insulation on hot exhausts. Take a proactive approach to safety.

2. Good housekeeping is a major loss prevention tool. Keeping the engine room and other spaces clean, tidy and free of oil is vital for a safe ship.
3. Include, as part of a machine overhaul, a risk assessment requiring that the chief engineer checks that the insulation has been correctly replaced and fitted after the overhaul. Masters should know who checks that the insulation material has been correctly fitted.

5. Consider as a company procedure that old insulation is always replaced with new insulation material. Trying to save a few dollars in not replacing damaged/unfit insulation is definitely not cost effective.

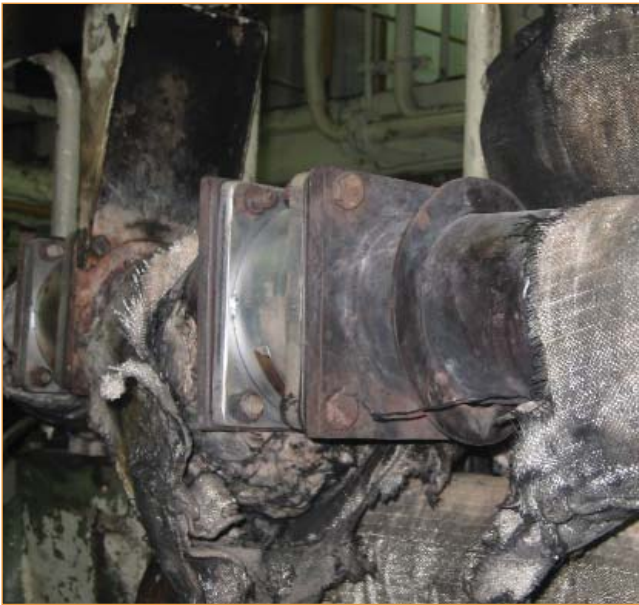
Another example – a major safety hazard

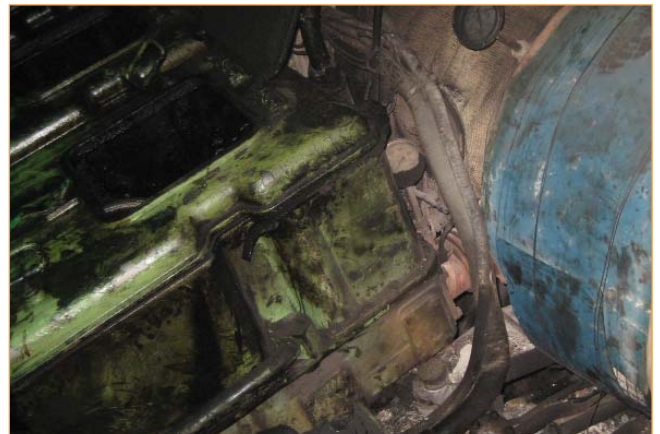
A dirty engine room is an unsafe engine room
